ReadMe FluentControl 3.5

Introduction

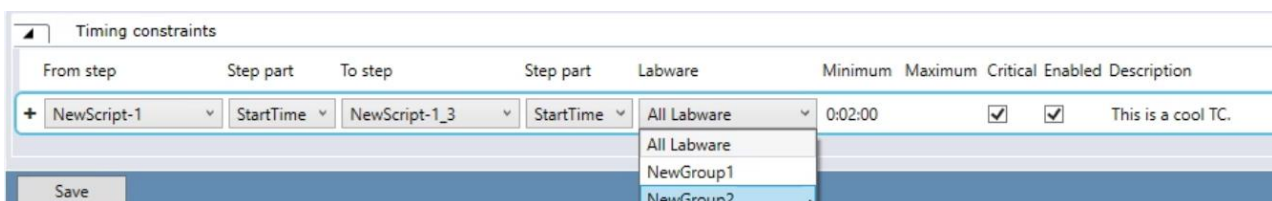
- New vertical scrollbar for the timing constraints section of the Process editor
- New 'Critical' checkbox for each timing constraint. If a critical timing constraint is violated, the run will finish with errors. Non-critical timing constraints may be used to optimize the schedule. Violation of non-critical timing constraints will not cause the run to finish with errors
- New 'Enabled' checkbox for each timing constraint. Disabled timing constraints are not used by the Scheduler. Checking or unchecking this checkbox triggers an update of the created schedule and can be used to find an optimal schedule for your assay
- Timing constraints can now be defined for individual Transfer steps
- Timing constraints can now be defined per labware group

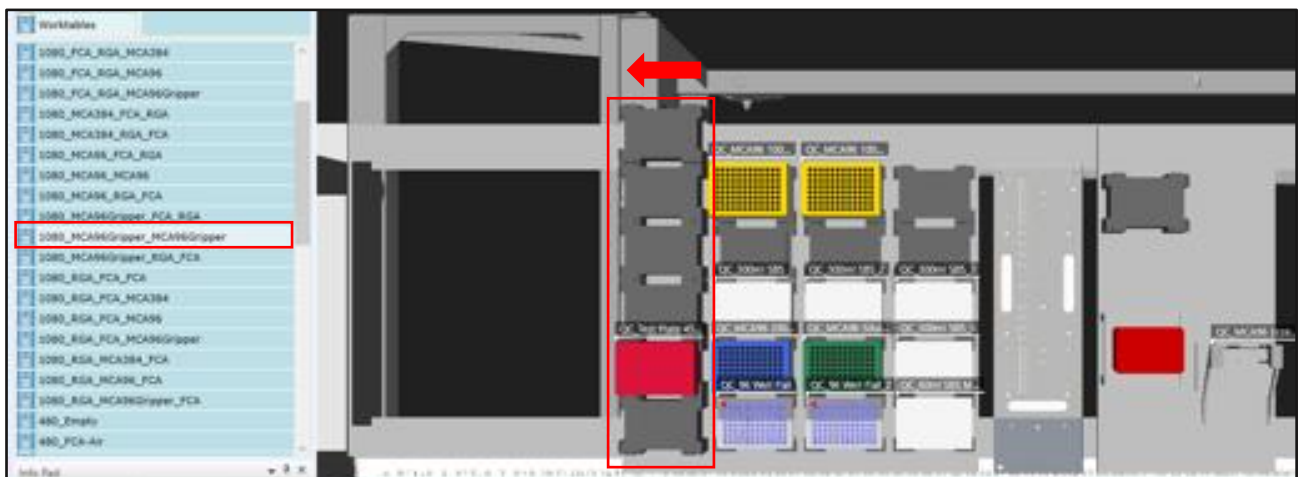
Balance connected to Te-Control COM: error message when using Get Weight (ID 121251)

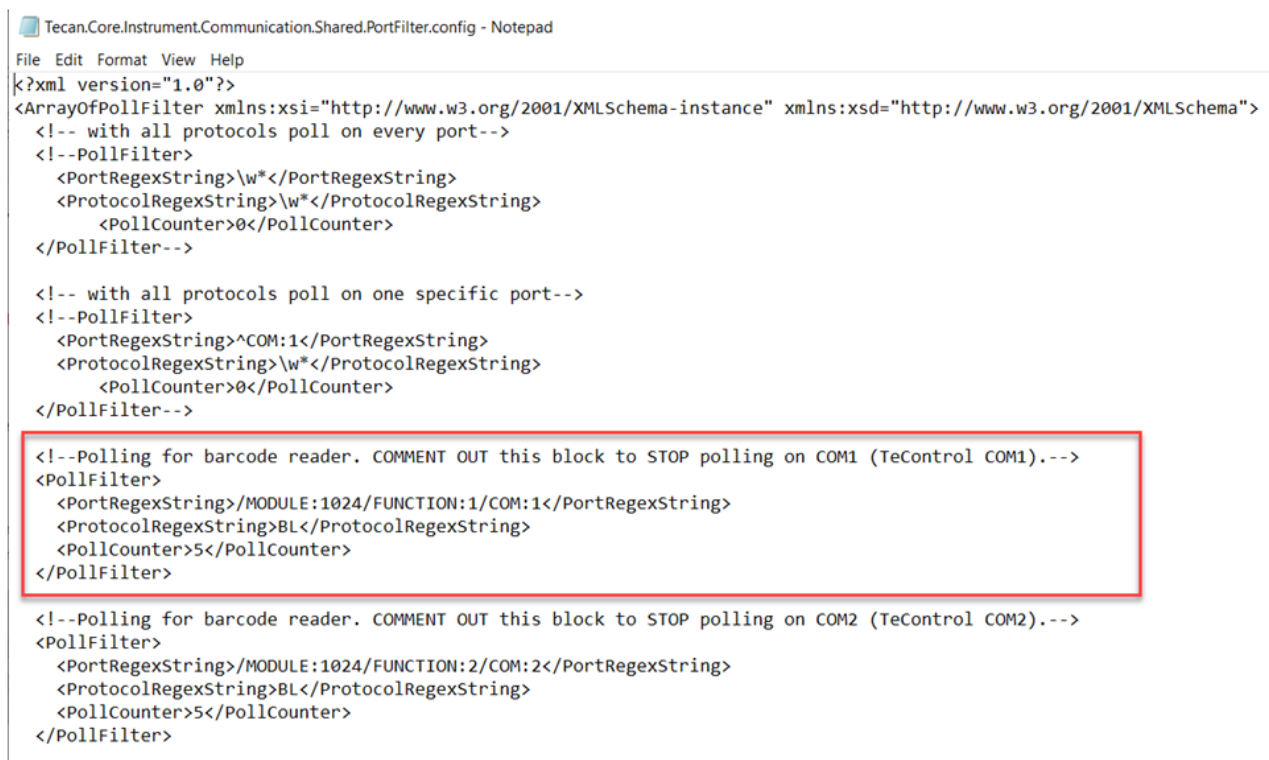
```
Tecan.Core.Instrument.Communication.Shared.PortFilter.config - Notepad
File Edit Format View Help
<?xml version="1.0"?>
<ArrayOfPollFilter xmlns:xsi="http://www.w3.org/2001/XMLSchema-instance" xmlns:xsd="http://www.w3.org/2001/XMLSchema">
  <!-- with all protocols poll on every port-->
  <!--PollFilter>
    <PortRegexString>w*[/PortRegexString>
    <ProtocolRegexString>w*[/ProtocolRegexString>
    <PollCounter>0[/PollCounter>
  </PollFilter-->
