ReadMe vControl 1.2

In vControl 1.2 we have many exciting new features and a lot of bugfixes. Here a list of the main new features:

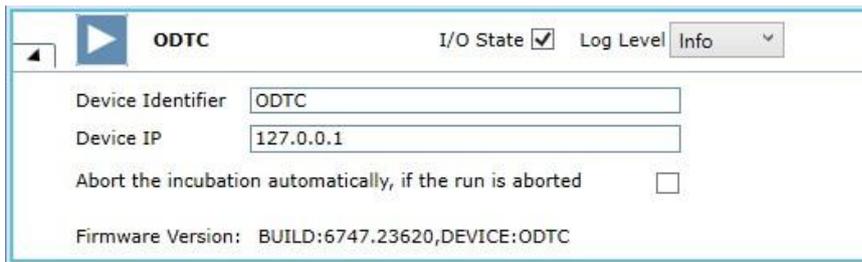
Additional known Issues
